New York State Department of Transportation

Yellow Flag NB23U4W004

BIN: 1065318

Location: Span 103 Girder G15 Bearing at Pier 102

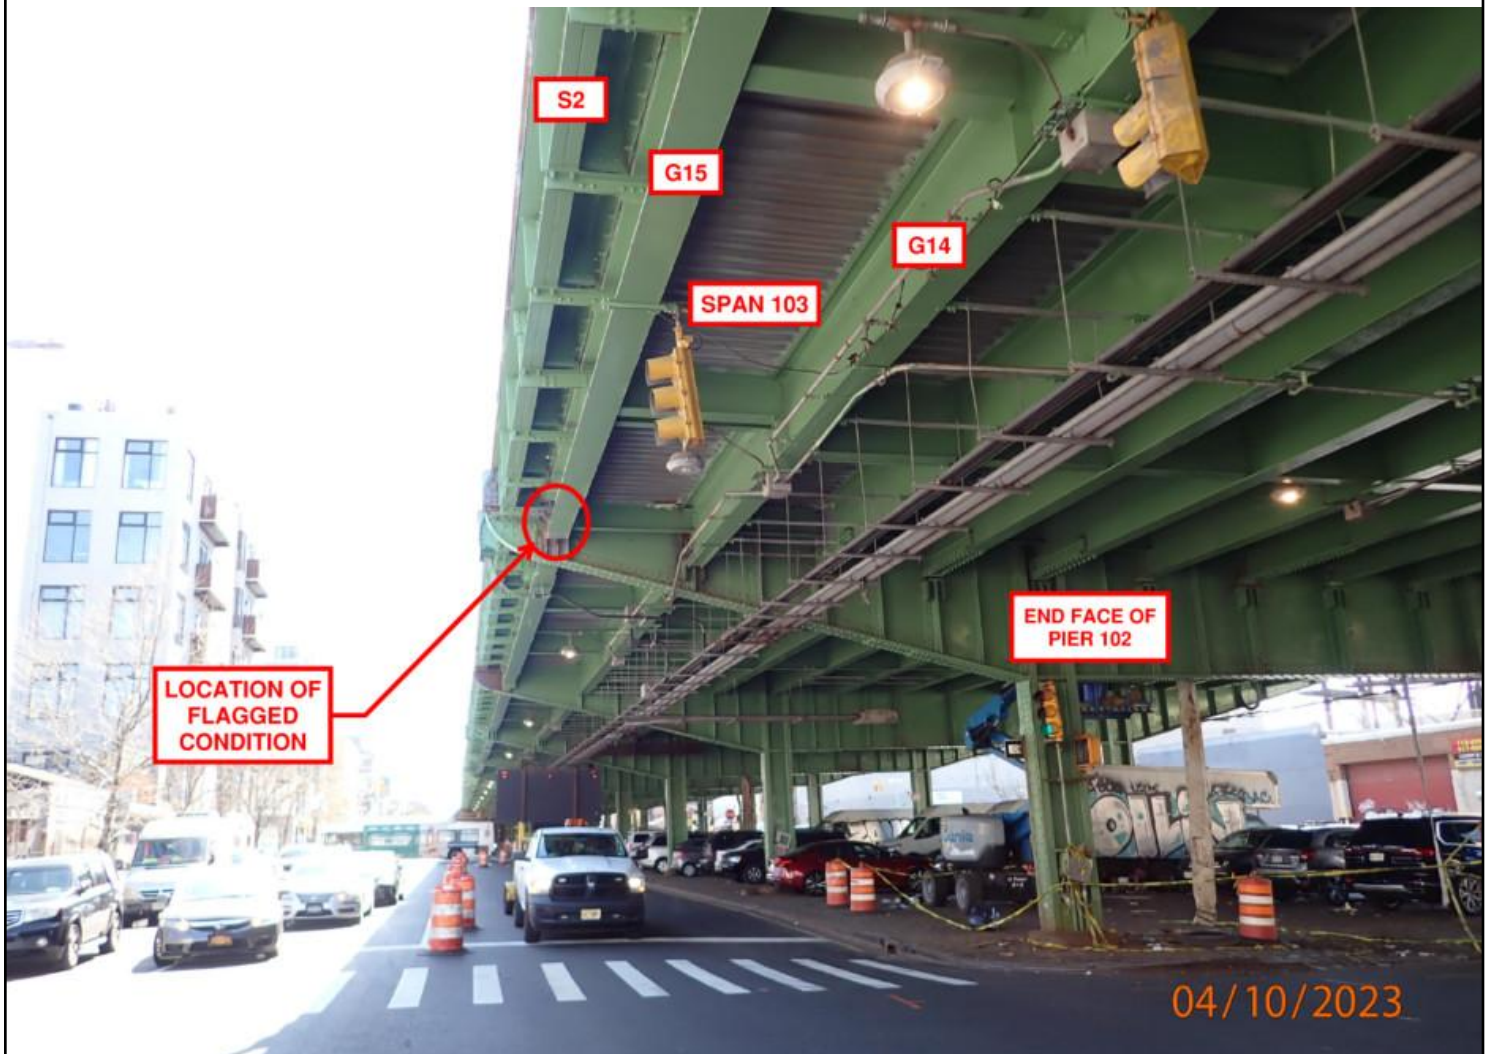
Photo Number: 2

The expansion bearing under Girder G15 on Span 103 side of Pier 102 is not functioning as designed. The bearing plate is presently overhanging the pedestal for 1/2" at right side of the bearing at a temperature of 54 degree F, (previously noted in the last inspection to be flush with the pedestal at both sides of the bearing at 55 degree F). Additionally, the sliding bearing plate is loose and moves when the inspection team hammers at the bearing plate (same as the previous inspection). The front keeper plate at the bearing is missing.

Attachment Description: General view of the flagged condition at the bearing under Girder G15 on the Span 103 side of Pier 102. Looking Begin

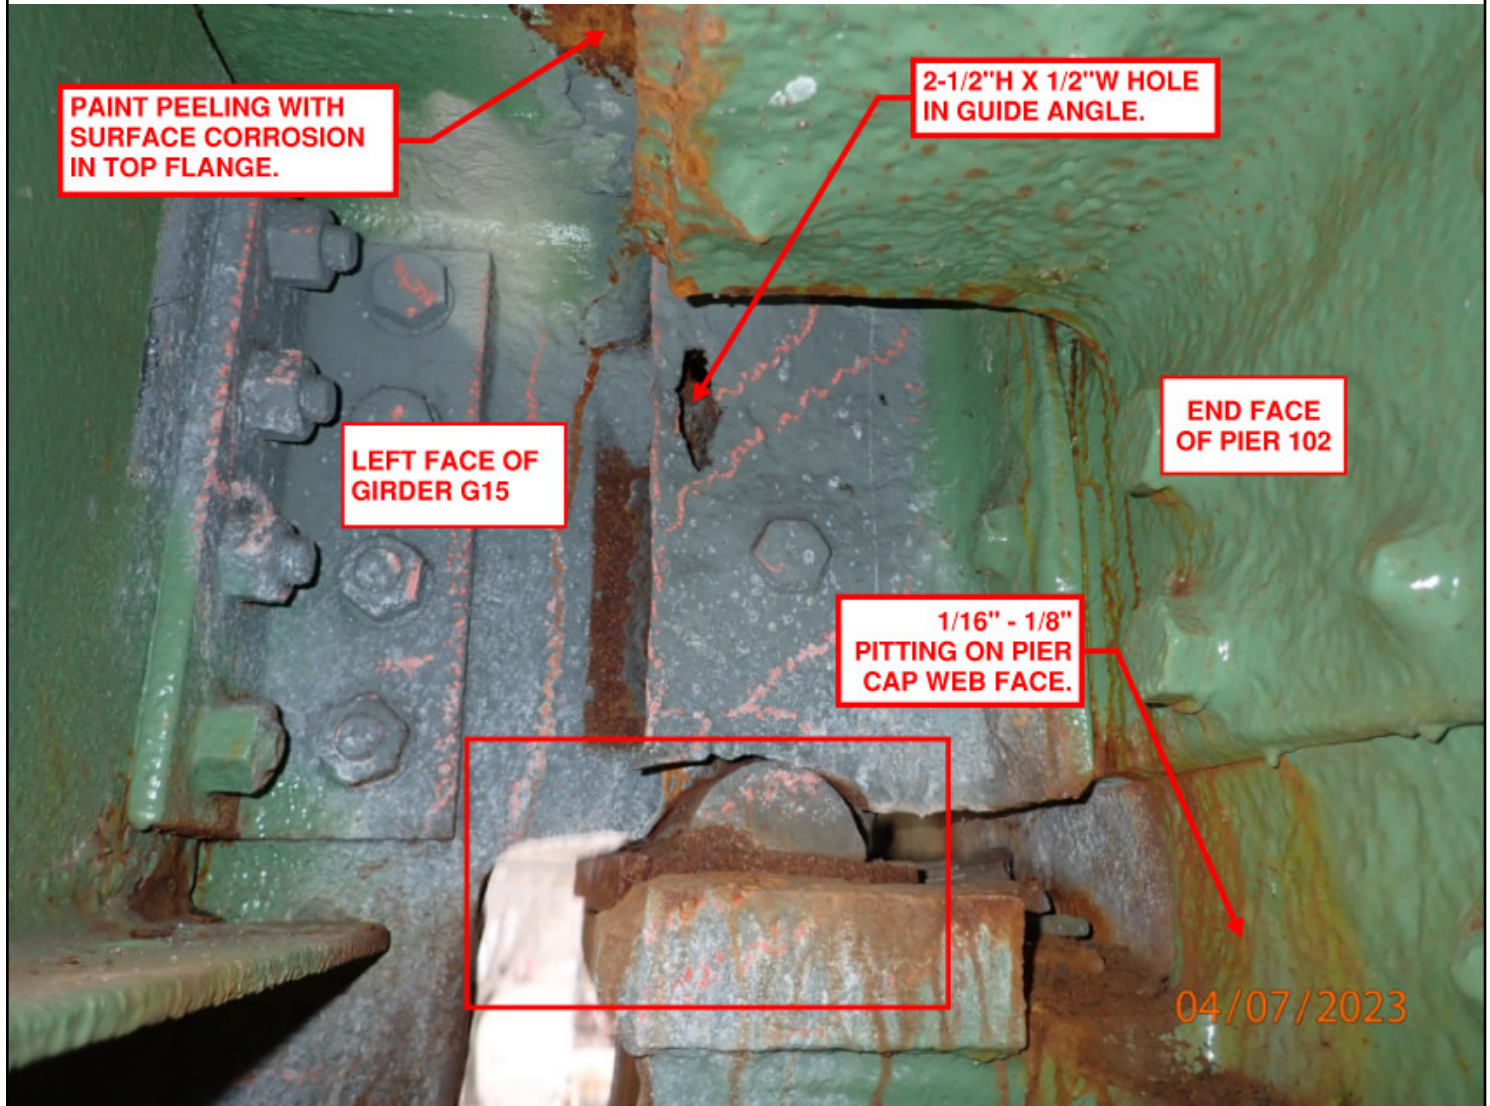
Photo Number: 3

Attachment Description: The left face of the bearing under Girder G15 on the Span 103 side at Pier 102. The bearing plate is loose and is flush with the pedestal with the front keeper plate missing. Looking Right. Note: Additional deterioration noted for reference only.

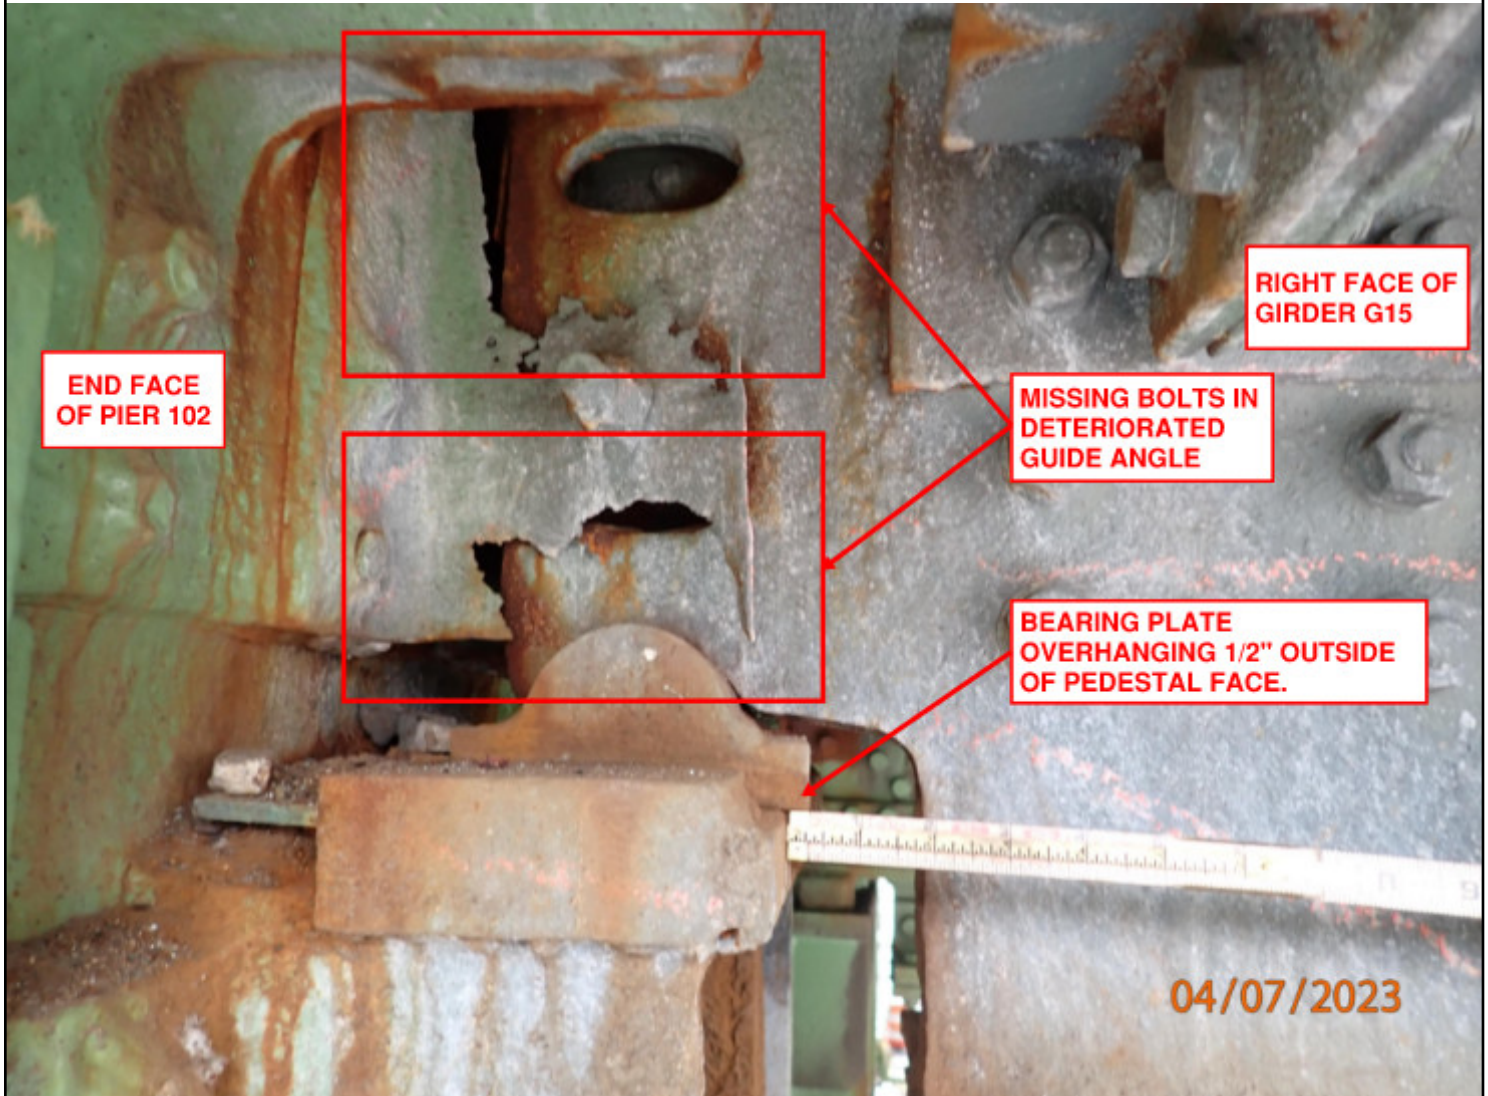
Photo Number: 4

- 1.The right guide angle exhibits an area of 100% section loss at the top for 5" x 5" and at the bottom for 4" x 2" (no change from the previous inspection).

Attachment Description: The right face of the bearing under Girder G15 on the Span 103 side at Pier 102. The bearing plate is loose and is overhanging the pedestal for 1/2" at right side, with areas of 100% section loss at the right guide angle. Looking Left.
